CULTURAL RESOURCE SURVEY PROPERTY IDENTIFICATION FORM

CRS#	S-11519
SPO Map	18-19-12
-	Lewes and
Hundred	Rehoboth
Quad	Lewes
Other	3-34-5-72

6.	PROJECT TITLE/ REASON FOR Western Parkway Project (Sect		plicable):				
	#: Form: 2 CRS 2 Main Building Form 4 CRS 3 Secondary Building	ig Form	Dwelling	perty types: I, Produce Marke Sheds, Stable,		Barn .	
	0 CRS 4 Archaeological Sit 1 CRS 5 Structure (Building		Water T	ower -			
	0 CRS 6 Structure (Land Fe		*******				
	0 CRS 7 Object Form		•			•	' '
	0 CRS 8 Landscape Elemen	nts Form					
	1 CRS 9 Map Form		N/A				
	0 CRS 14 Potential District	Form				· · · · · · · · ·

8.	SURVEYOR INFORMATION:						
	Surveyor name:	Gerald M. I	Kuncio				
	Principal Investigator name:	Gerald M, I	Kuncio	1.4			
	Principal investigator signature:		ewlest	Buren	<u> </u>		
	Organization:	Skelly and	Loy, Inc.	-		Date:	12/2005

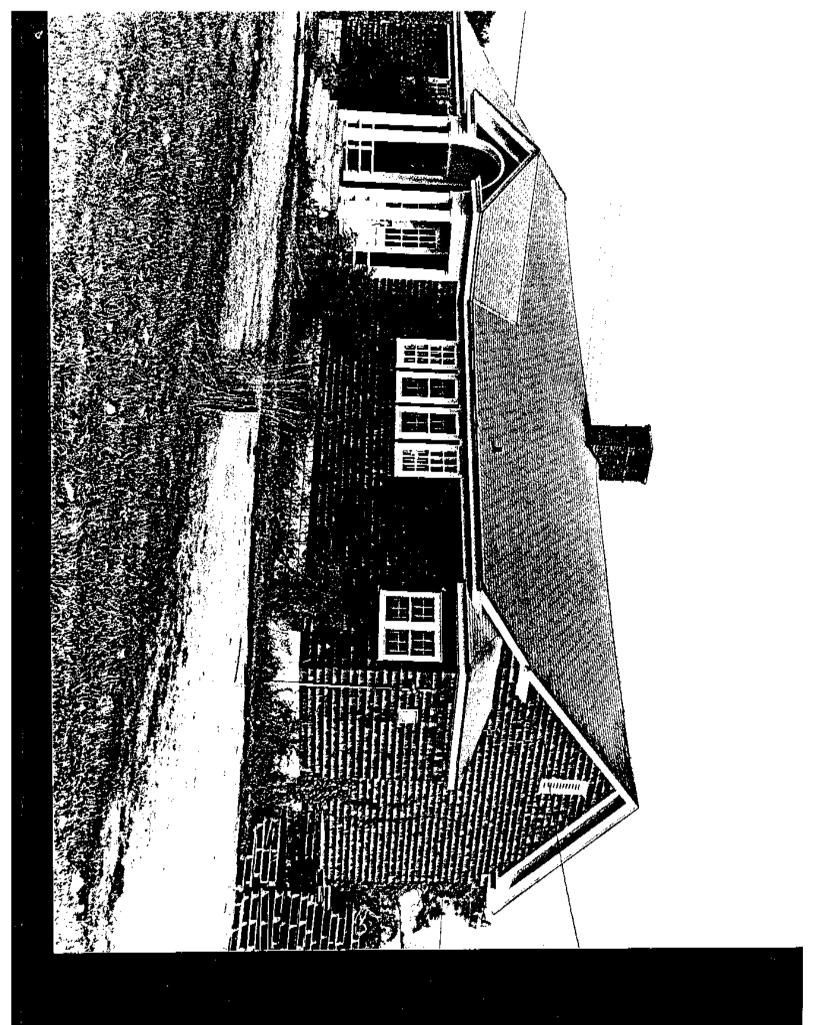
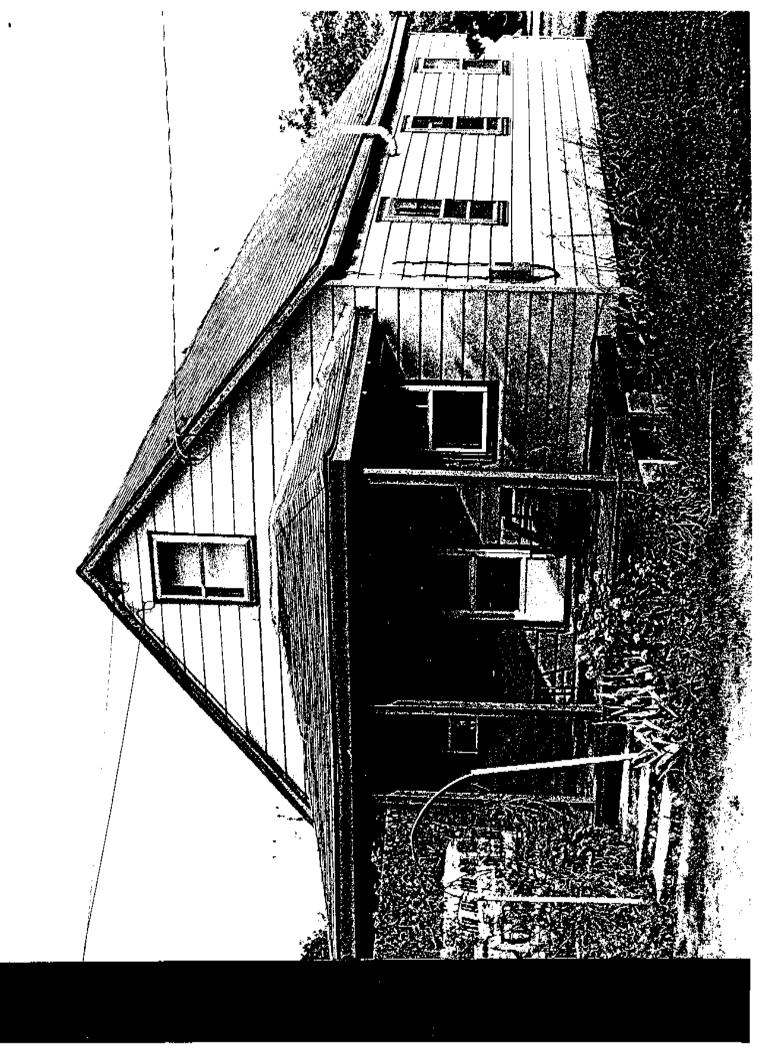
BELLTOWN SCHOOL (BELLTOWN HISTORIC DISTRICT)
SUSSEX CO., DE
RICHARD WEBSTER
APRIL 1988
BAHP
FROM SOUTHEAST
3-34-5-94

Description: The Belltown School is a large one story wood framed rectangular block with a gabled roof. It is located on the north side of Route 9, west of its intersection with Delaware Route 1. The exterior walls are sheathed in cedar shingles above a rusticated CMU foundation, and the roof is covered with composite shingles. The southern slope of the roof extends further than the northern slope. The facade or southern elevation of the main block of the school consists of three bays, composed of an axial entrance and two flanking window Each window opening is filled with a rank of four 9/9 A gable roofed porch at the top of four concrete steps shelters the front entrance. The porch roof is supported on a simple architrave resting on paired battered wooden posts and pilasters applied to shingled cheek walls. The molded cornice returns on the gable end of the porch roof frame an arched Triple railings line the sides of the porch. double-leafed entrance door has nine lights in each leaf and is set in plain surrounds. The eastern and western elevations lack fenestration; a louvered wooden vent is centered in each gable. Molded cornice returns and a boxed cornice furnish the only other gable detail. Composite shingles cover the roof, where a large brick chimney rises from the center of the ridge. At the southeast corner of the building, a small one story hip roofed wing extends the facade one bay to the east. A paired window consisting of two 6/6 sash occupies the facade of the addition.

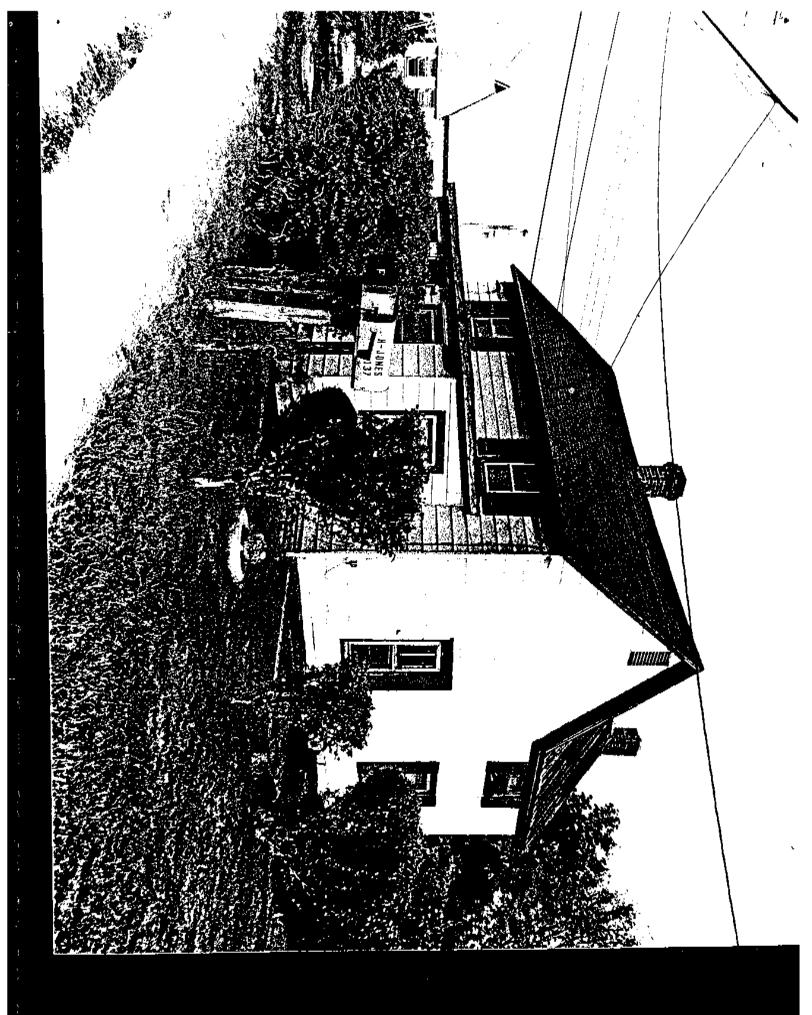
DANIEL JONES HOUSE (BELLTOWN HISTORIC DISTRICT)
SUSSEX CO., DE
RICHARD WEBSTER
APRIL 1988
BAHP
FROM SOUTHEAST
3-34-5-124

The Daniel Jones House is a two story gable Description: roofed, wood framed, ell-plan dwelling, two bays wide and two bays deep. The southern elevation or facade faces Route 9, with a one story shed roofed enclosed porch of three bays obscuring the first story of the main block. A two story, gable roofed rear ell extends from the easternmost bay of the northern elevation, with a one story addition on the western elevation of Above the CMU foundation the exterior walls are sheathed in composite shingles and metal siding; the roof has composite shingles on the main block with corrugated metal covering the roof of the rear ell. Window openings are filled with 1/1 sash in plain surrounds, except on the eastern elevation where 2/2 sash occupy the one bay of the main block first story, and on the west where a 3/1 sash window occupies the second story. A corbeled brick chimney is centered on the ridge of the main block; an exterior brick chimney is centered on the northern elevation of the ell. Located to the northeast of the dwelling is a rectangular one story wood framed shed, covered with horizontal board siding and tar paper. Its roof is covered with boards.

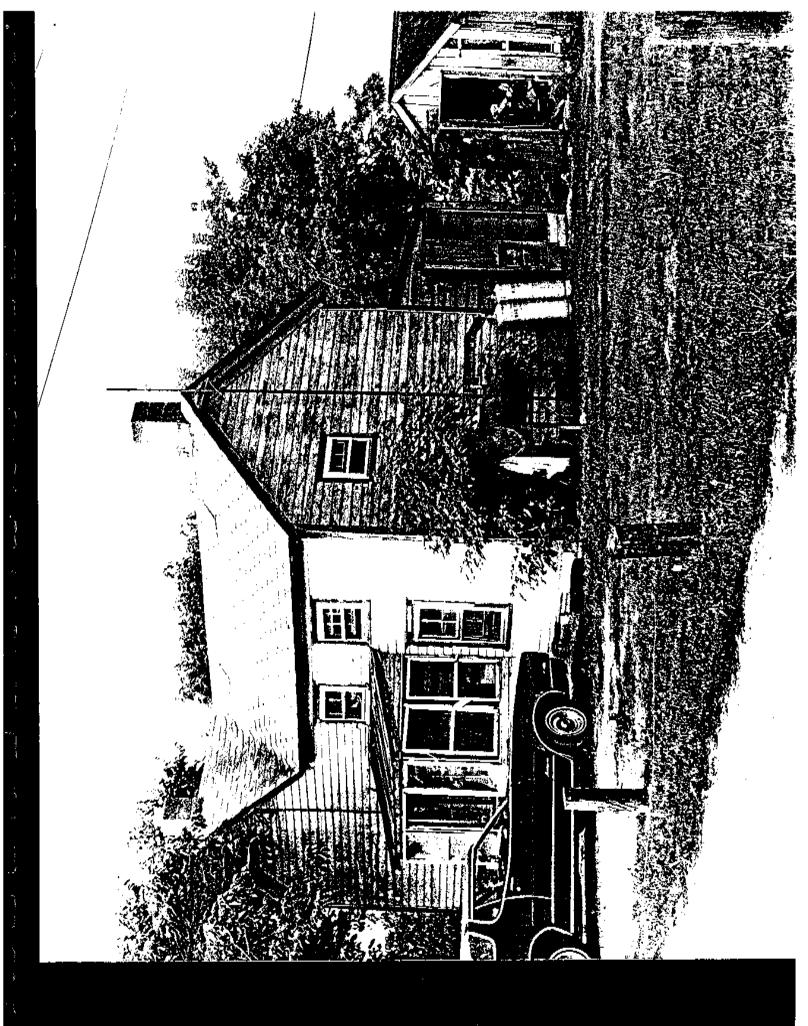
MARTHA NORWOOD HOUSE (BELLTOWN HISTORIC DISTRICT)
SUSSEX CO., DE
RICHARD WEBSTER
APRIL 1988
BAHP
FROM NORTHEAST
3-34-5-139

Description: The Martha Norwood House is a wood framed dwelling composed of a two story gable roofed main block and a two story gable roofed rear ell, with a one story shed roofed addition filling in the space bordered by the arms of the ell. Corrigated metal stripping conceals the foundation below clapboard covered exterior walls. Composite shingles sheathe the roof slopes, where two concrete block chimneys rise from the ridge, one at the eastern end of the main block and one at the northern end of the rear ell. The southeastern elevation faces Route 9 and forms a three bay facade. On the first story of the facade a four light sash entrance door is centered between 2/2 sash windows, and the three bays of the second story consist of squared 2/2 sash windows. On the gable end elevations of the main block, facing northeast and southwest, there are no windows. On the northeastern elevation of the rear ell a 1/1 sash window occupies the second story. On the southwestern

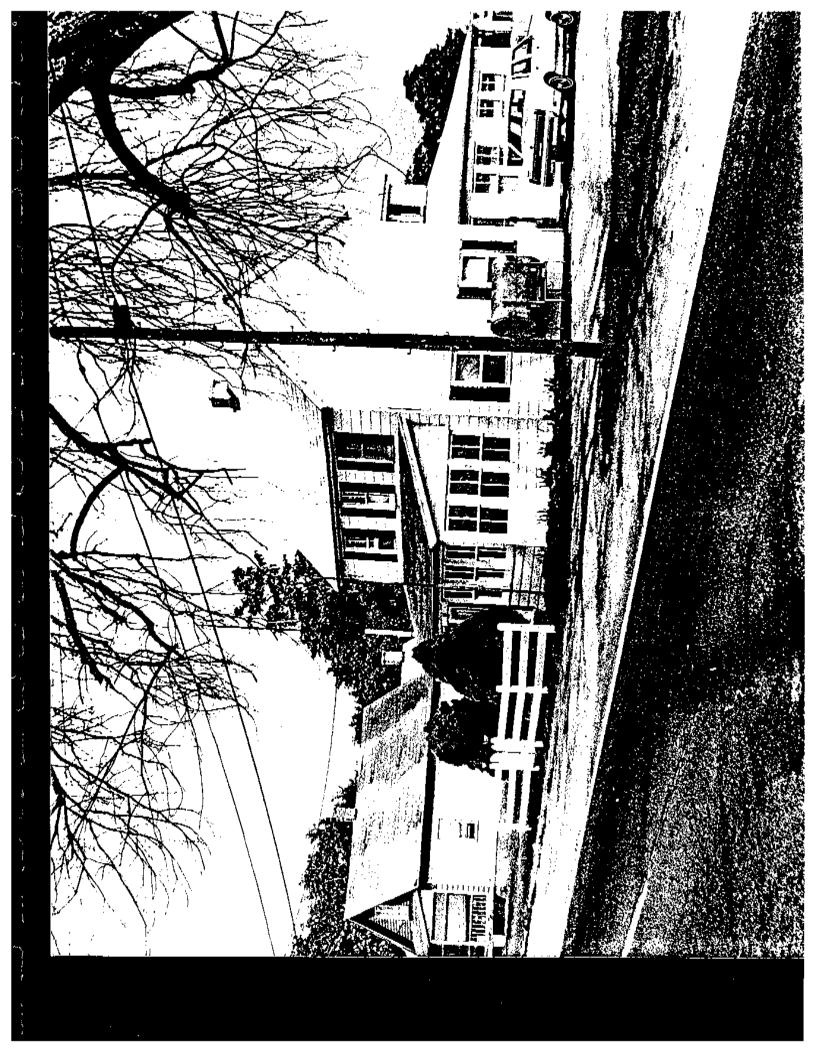
LUCILLE I. WILLIAMS HOUSE (BELLTOWN HISTORIC DISTRICT)
SUSSEX CO., DE
RICHARD WEBSTER
APRIL 1988
BAHP
FROM NORTHWEST
3-34-5-193

Description: The Lucille I. Williams House is a wood framed dwelling composed of a two story gable roofed main block and a two story gable roofed rear ell, to which an enclosed one story shed roofed front porch and an enclosed one story shed roofed rear porch have been added. Above the concrete block foundation the walls are clad in metal siding. Composite shingles cover all the roof slopes, and a brick chimney is centered on the ridge of the main block roof. The northwestern elevation of the main block faces Route 9 and forms a three bay facade. Above

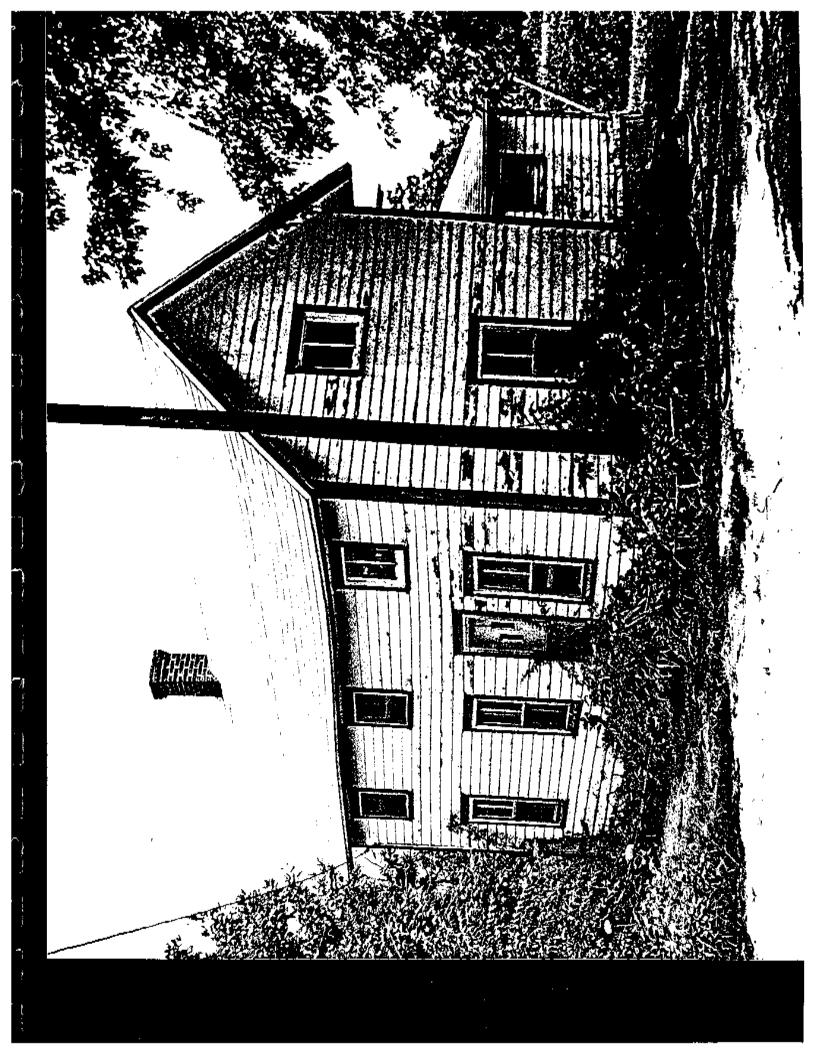
MAULL HEIRS HOUSE (BELLTOWN HISTORIC DISTRICT)
SUSSEX CO., DE
RICHARD WEBSTER
APRIL 1988
BAHP
FROM SOUTHEAST
3-34-5-194

The Maull Heirs House is a wood framed ell-plan dwelling composed of two gable roofed two story sections joined to form an ell, with a one story shed roofed addition filling in most of the space enclosed by the ell. No foundation is visible below the clapboard covering the exterior walls. On the southwestern elevation of the main block, which faces the alley and forms the facade, the entrance door is a modern paneled replacement with three lights. The door is located to the southeast of the center of the facade, with two 2/2 sash windows to the northwest and one 2/2 sash window to the southeast. Directly above the three first story windows are three square, two light sash windows on the second story. On the southeastern elevation, a gable end, one square two light sash window is centered in the gable above a 2/2 sash window on the first Extending the northwestern elevation of the main block to the northeast is the two story rear ell, containing 6/2 sash windows on the first story and 3/3 casement windows on the second story. The window and door openings are trimmed with plain surrounds, including the louvred windows in the one story shed roofed addition. Composite shingles cover all the slopes of the roof. Two corbeled brick chimneys rise from the ridges of the gabled roofs, one near the west end of the main block and one near the northwest end of the rear ell.

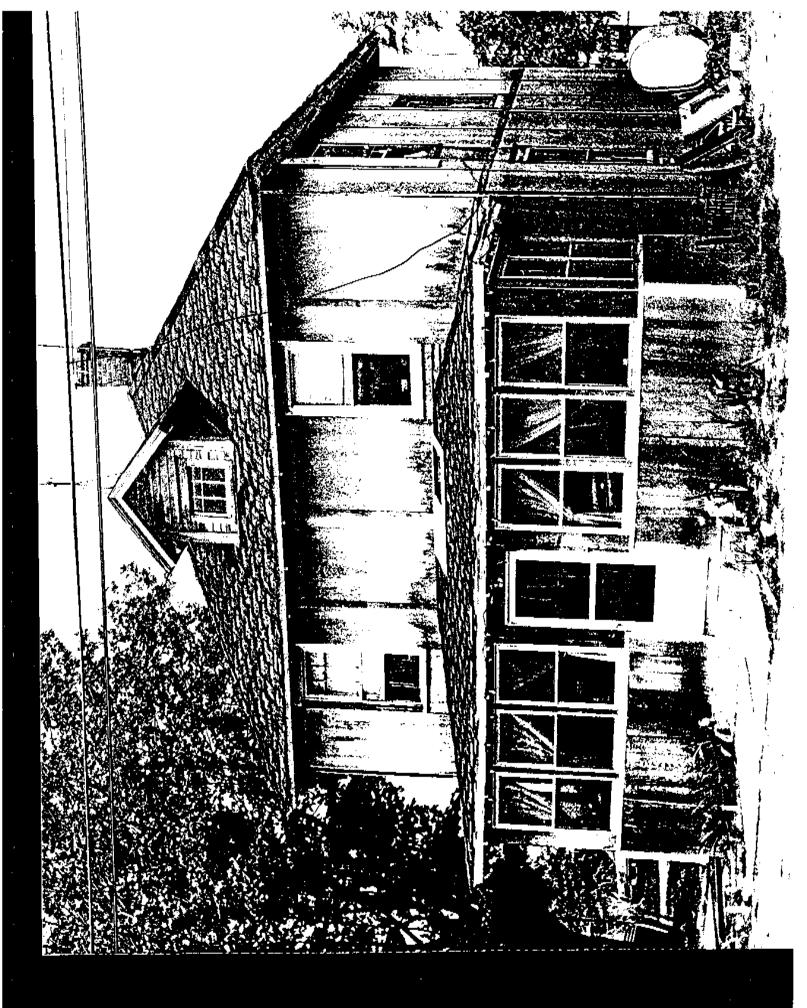
GARLAND R. BRISCOE HOUSE (BELLTOWN HISTORIC DISTRICT)
SUSSEX CO., DE
RICHARD WEBSTER
APRIL 1988
BAHP
FROM SOUTHEAST
3-34-5-196

Description: The Garland R. Briscoe House is a two and a half story wood framed, hip roofed square dwelling set on a concrete block foundation. Covering the front or northwestern slope of the roof are wooden shingles; the other slopes are covered in composite shingles. A gable roofed dormer covered with clapboarding occupies the center of the northwestern slope of the roof, and a corbeled brick chimney rises from the southeastern slope near the peak. Vertical board paneling sheaths the walls both of the main block of the house and of the one story hip roofed enclosed front porch. Six 1/1 sash windows flank the front porch door. On the facade elevation of the house, the four light sash entrance door is flanked by two 5 vertical/1 sash windows, set below two 3/1 sash windows on the second story. This pattern is repeated on the southwestern elevation, where two 3/1 sash windows occupy the second story and one 5/1 sash occupies the first story. On the northeastern elevation, however, the second story windows are 1/1 and 2/2 sash while the first story window is 5/1 sash. All the windows have plain surrounds with a molding strip atop the lintels, forming a small hood mold. A second enclosed porch is located on the rear elevation and at the easternmost end of the northeastern elevation. One outbuilding stands on this property, a garage in deteriorated condition. Located to the northeast of the house and accessed by an alley which parallels the southwest elevation of the dwelling, the rectangular one story frame garage is set on concrete block piers and is covered with vertical board paneling. A gable roof is sheathed in corrugated metal.

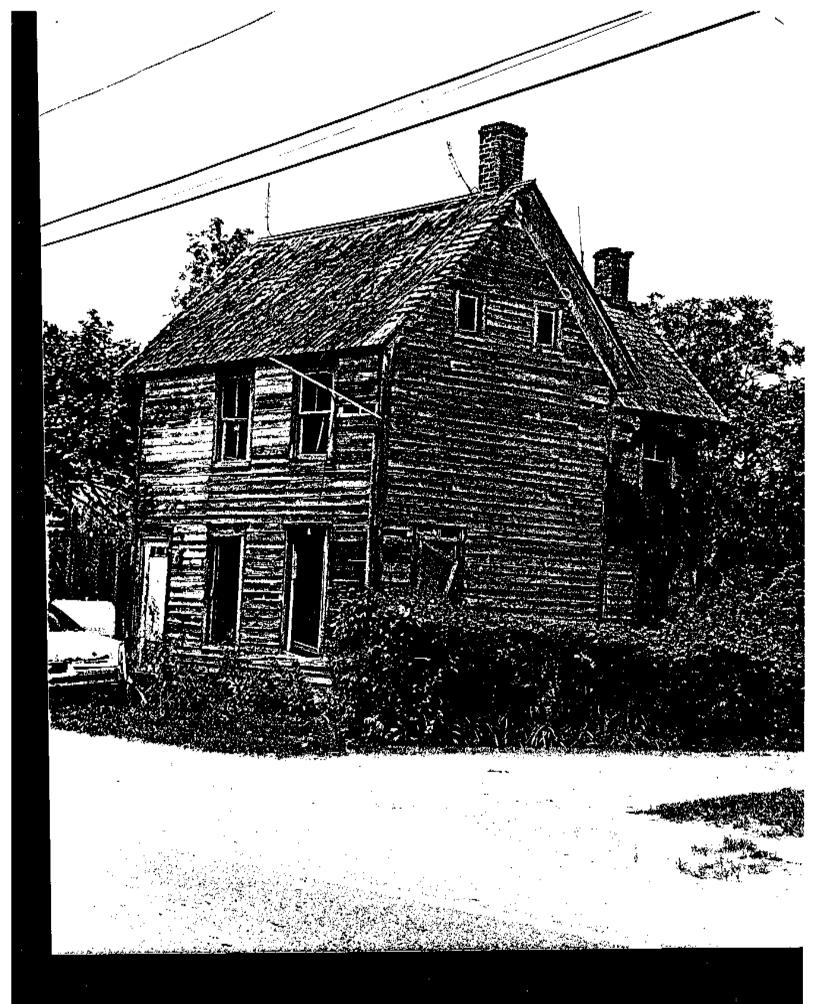
VIRGINIA WILLIAMS HOUSE (BELLTOWN HISTORIC DISTRICT)
SUSSEX CO., DE
RICHARD WEBSTER
APRIL 1988
BAHP
FROM SOUTHEAST
3-34-5-197

Description: The Virginia Williams House is a two and a half story wood framed dwelling with a steeply pitched gabled roof and an adjoining rear wing of similar form and materials. The street facade is three bays wide with a door in the lower left side. Windows are 2/2 sash. The exterior is sheathed in claboard siding. A simple brick chimney rises inside the north wall of the main block and another inside the west wall of the wing. The building is abandoned and in poor condition.

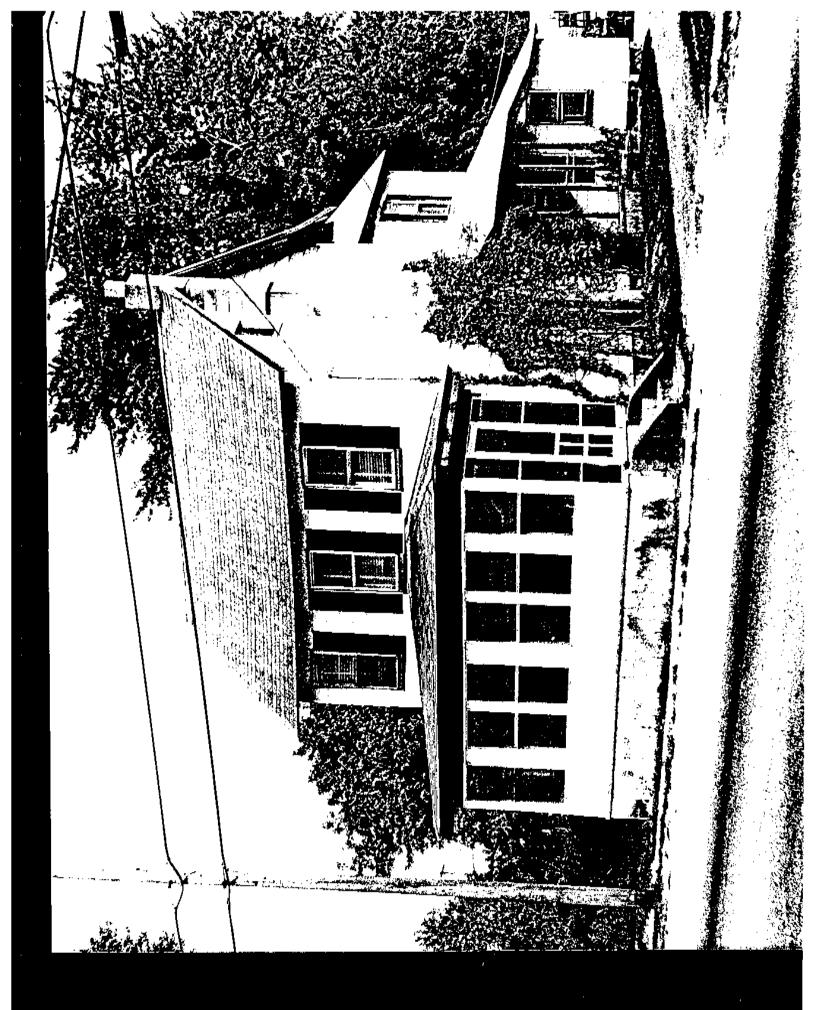
JEROY CARTER HOUSE (BELLTOWN HISTORIC DISTRICT)
SUSSEX CO., DE
RICHARD WEBSTER
APRIL 1988
BAHP
FROM NORTHWEST
3-34-5-208.1

Description: The Jeroy Carter House is a rectangular one story wood framed dwelling, sited with the northwestern gable and elevation facing Route 9. Corrugated metal covers the foundation below walls sheathed in both composite shingles and brick cladding. The gable roof, covered with composite roofing material, has a slight overhang. On the northwestern elevation or facade an axial sash entrance door is flanked by 1/1 sash windows below a boarded window in the peak of the gable. On the southwestern side elevation, the westernmost two-thirds of the wall is covered with composite shingle cladding and contains one 1/1 sash window. The southernmost one-third of the southwestern elevation is covered with composite brick sheathing, and contains one 1/1 sash window and an entrance door at the southernmost end. Three 1/1 sash windows are symmetrically placed in the northeastern elevation. All window and door openings are set in plain surrounds. An exterior concrete block chimney rises next to the southeastern elevation to the south of Two outbuildings stand on this property, a the roof ridge. shed covered with vertical board siding and a shed covered with clapboards. Both sheds are wood framed, rectangular and have The clapboard covered shed is located to the gable roofs.

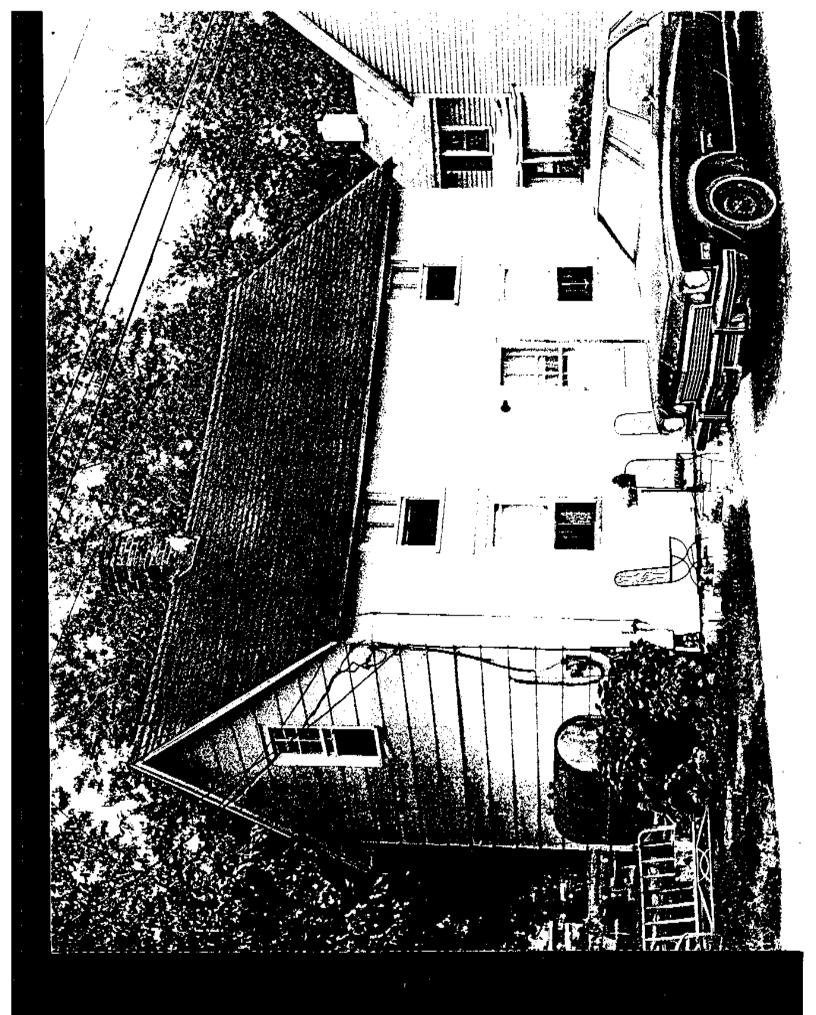
JOHN H. MAKER HOUSE (BELLTOWN HISTORIC DISTRICT)
SUSSEX CO., DE
RICHARD WEBSTER
APRIL 1988
BAHP
FROM SOUTH
3-34-5-210

Description: The John H. Maker House is a two story wood framed gable roofed dwelling, composed of a main block and a rear ell which together create an ell plan. Above the concrete block foundation the walls are covered with composite shingles. the overhanging roof, sheathed with composite shingles, two corbeled brick chimneys rise from the ridge: one to the southwest of center on the main block, and one at the northwest end of the rear ell. On the southeastern elevation, which faces Route 285 and forms the facade, four window openings are Two square 2/2 sash windows occupy the symmetrically placed. second story and two 1/1 sash windows occupy the first story. The four light sash entrance door is located northeast of the center of the facade. On the gable ends of the main block, sash windows are set in the peak of the gable: on the southwestern elevation, a 4/4 sash window, and on the northeastern, a 2/2sash window. The northeastern elevation of the ell has a 2/2 sash window on the first story with a 3/3 casement window on the second story. One outbuilding stands on this property, a one story square wood framed shed. Located to the north of the dwelling at the end of a driveway which parallels the northeast elevation of the house, the shed has a corrugated metal covered shed roof and walls that are sheathed in plywood.
